## Existing condition of the substructure (abutment)

**Ranges from poor to fair**

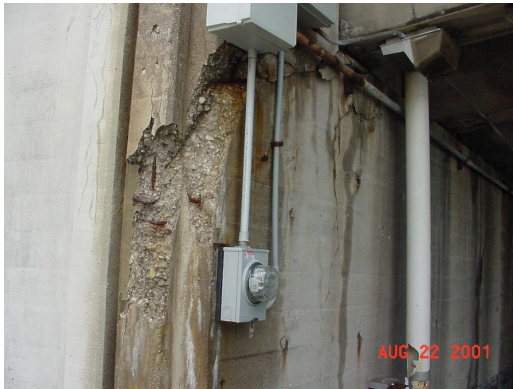
These pictures show the deterioration of the east abutment.

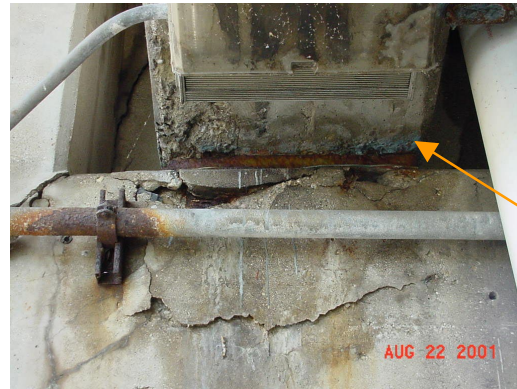
**Girder**

Note the deterioration of the abutment under the girder in the right photo above.

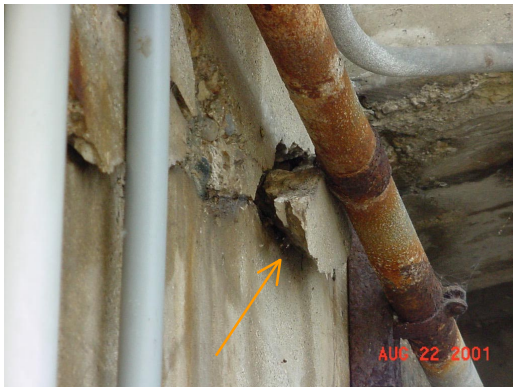
The left photo above shows a section of concrete that has failed and is being held in place by the utility pipe. The right photo shows a failure that has occurred in the back wall of the east abutment.
